PIC16F88X Family Silicon Errata and Data Sheet Clarification

The PIC16F88X family devices that you have received conform functionally to the current Device Data Sheet (DS41291F), except for the anomalies described in this document.

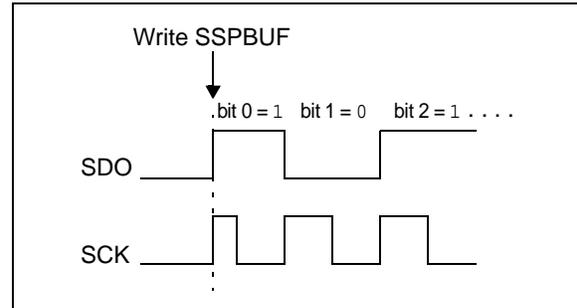
FIGURE 1: SCK PULSE VARIATION USING TIMER2/2

When the SPI is using Timer2/2 as the clock source, a shorter than expected SCK pulse may occur on the first bit of the transmitted/received data (Figure 1).

To avoid producing the short pulse, turn off Timer2 and clear the TMR2 register, load the SSPBUF with the data to transmit and then turn Timer2 back on. Refer to Example 1 for sample code.

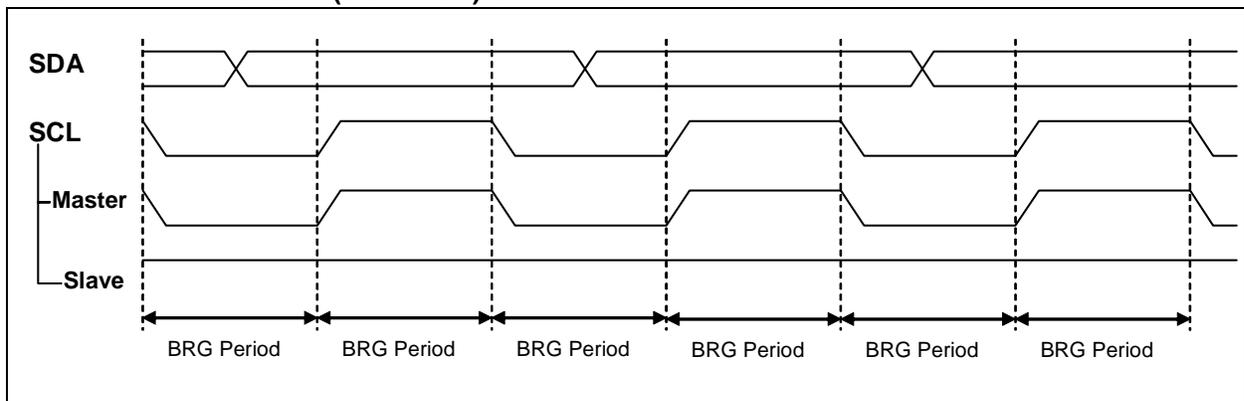
FIGURE 1: ACTUAL (CORRECT) OPERATION WITHOUT CLOCK STRETCHING

Figure 1 illustrates an expected I²C transmission in which the SCL line is completely controlled by the master device and the slave device does not attempt to stretch the clock period.

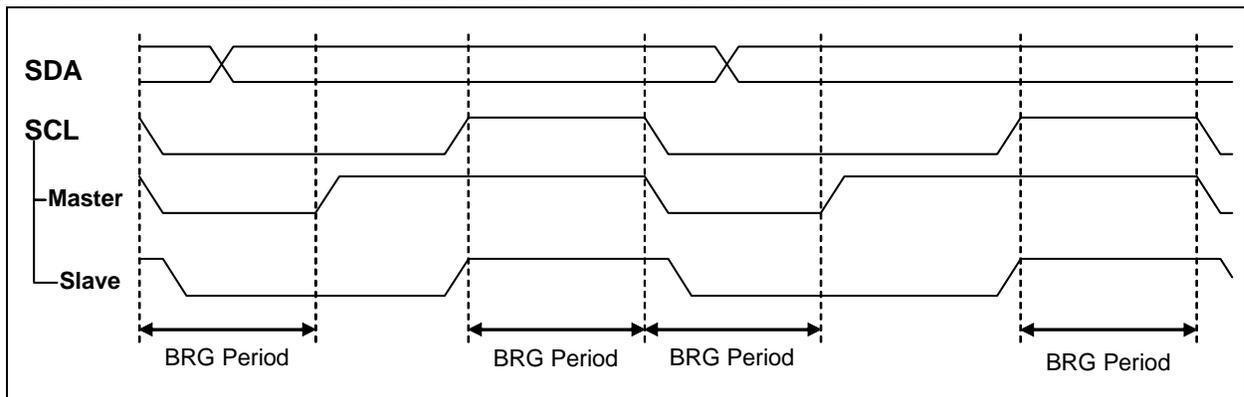
FIGURE 2: EXPECTED OPERATION WITH CLOCK STRETCHING

Figure 2 illustrates the expected operation of an I²C transmission in which the slave device has stretched the clock period by holding the SCL line low. The high time of the SCL pulse is constant, regardless of the duration of the clock stretch.

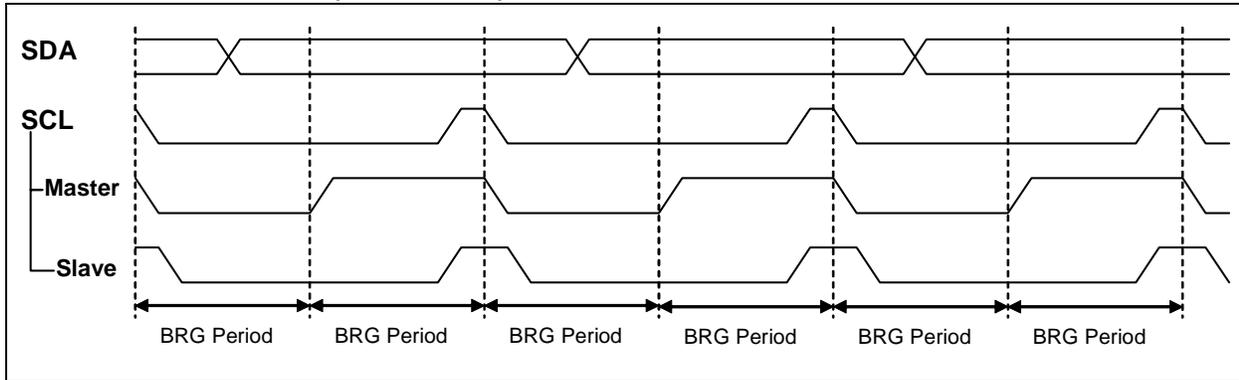
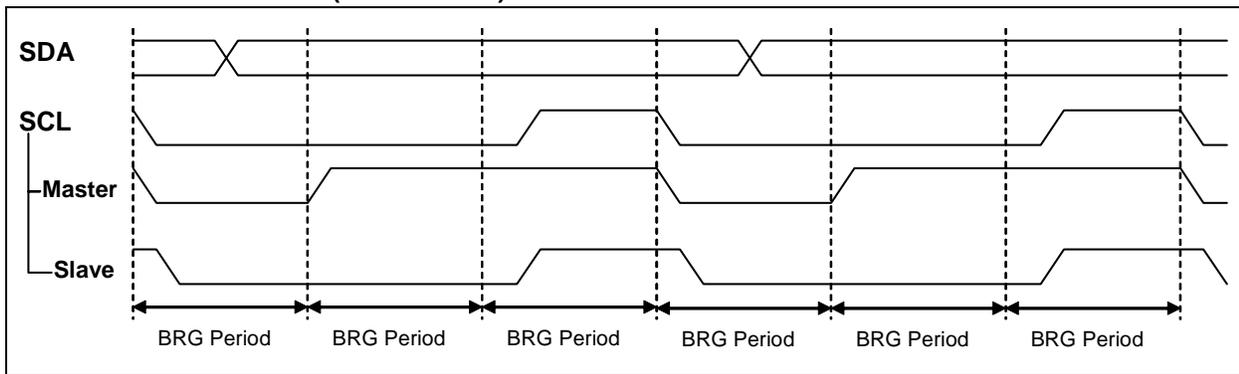
The current implementation does not ensure accurate SCL high time. During clock stretch, the MSSP device will erroneously continue running the BRG counter. At the end of the clock stretch the BRG counter continues to count down for the remainder of the BRG period, and then the MSSP device will immediately resume transmitting the data.

Figure 3 and Figure 4 illustrate an actual I²C transmission in which the slave has stretched the clock period by holding the SCL line low. Note that the high time of the SCL signal has shortened from the expected time.

Set the communication speed to match the slowest device on the bus. This ensures that no slave device will perform clock stretching.

It is possible to dynamically adjust the communication speed to match the device being addressed by modifying the BRG register. However, the behavior of slower slave devices must be understood and speed adjustments made such that no slave performs clock stretching.
