## PIC24FJ256GB110 Family Silicon Errata and Data Sheet Clarification

The PIC24FJ256GB110 family devices that you have received conform functionally to the current Device Data Sheet (DS39897C), except for the anomalies described in this document.

The silicon issues discussed in the following pages are for silicon revisions with the Device and Revision IDs listed in [Table 1](#). The silicon issues are summarized in [Table 2](#).

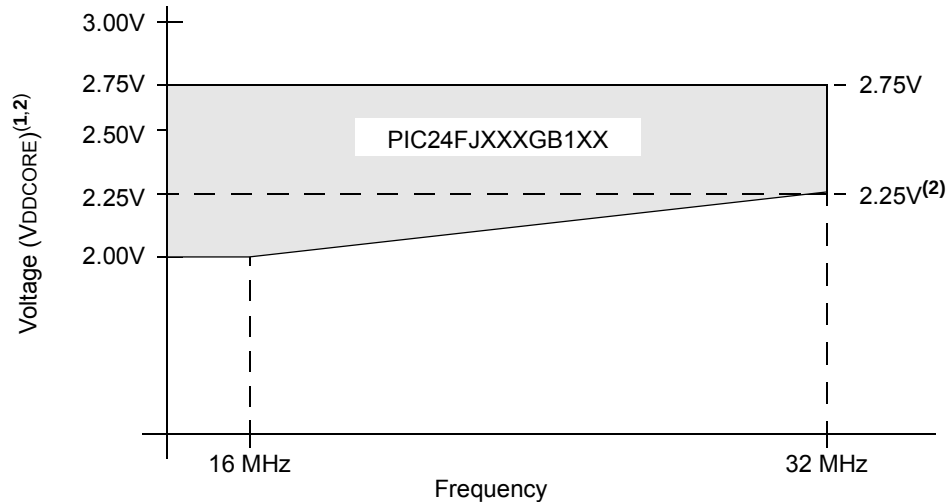
**FIGURE 29-1: PIC24FJ256GB110 FAMILY VOLTAGE-FREQUENCY GRAPH (INDUSTRIAL)**

Figure 29-1 (“PIC24FJ256GB110 Family Voltage-Frequency Graph”) is amended by adding an additional footnote. The updated figure is shown below (changes in **bold**; bold in original removed for clarity).

For frequencies between 16 MHz and 32 MHz,  $F_{MAX} = (64 \text{ MHz/V}) * (V_{DDCORE} - 2V) + 16 \text{ MHz}$ .

**Note 1:** When the voltage regulator is disabled, V<sub>DD</sub> and V<sub>DDCORE</sub> must be maintained so that  $V_{DDCORE} \leq V_{DD} \leq 3.6V$ .
