## PIC24FJ256GB110 Family Silicon Errata and Data Sheet Clarification

The PIC24FJ256GB110 family devices that you have received conform functionally to the current Device Data Sheet (DS39897C), except for the anomalies described in this document.

The silicon issues discussed in the following pages are for silicon revisions with the Device and Revision IDs listed in [Table 1](#). The silicon issues are summarized in [Table 2](#).

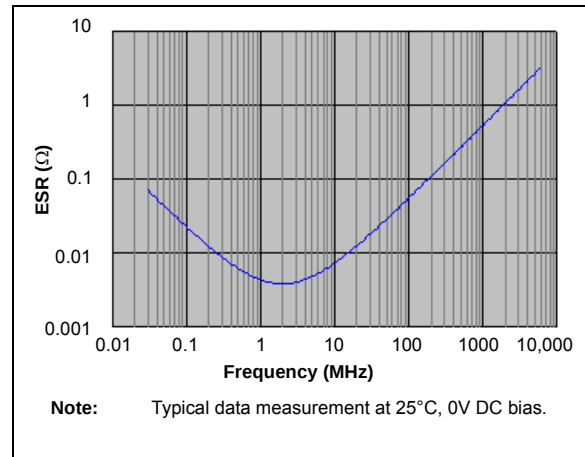
**FIGURE 2-3 FREQUENCY vs. ESR PERFORMANCE FOR SUGGESTED VCAP**

Designers may use **Figure 2-3** to evaluate ESR equivalence of candidate devices.

The placement of this capacitor should be close to VCAP/VDDCORE. It is recommended that the trace length not exceed 0.25 inch (6 mm). Refer to **Section 29.0 “Electrical Characteristics”** for additional information.

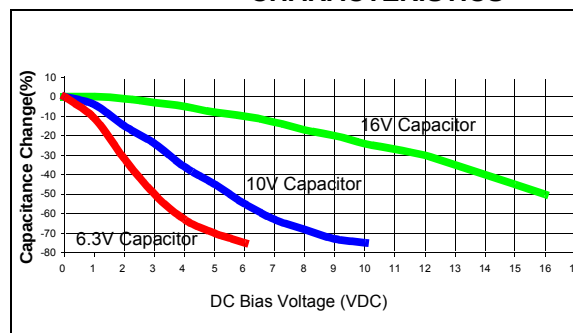
**FIGURE 2-4 DC BIAS VOLTAGE vs. CAPACITANCE CHARACTERISTICS**

A typical DC bias voltage vs. capacitance graph for 16V, 10V and 6.3V rated capacitors is shown in Figure 2-4.

When selecting a ceramic capacitor to be used with the internal voltage regulator, it is suggested to select a high-voltage rating, so that the operating voltage is a small percentage of the maximum rated capacitor voltage. For example, choose a ceramic capacitor rated at 16V for the 2.5V core voltage. Suggested capacitors are shown in Table 2-1.
